# Manhole Inspection Summary

Manhole # S43A2\_004MH

Insp Date: **12/11/07 8:50 AM**

**Location** Address: **1011 E Patapsco Ave**

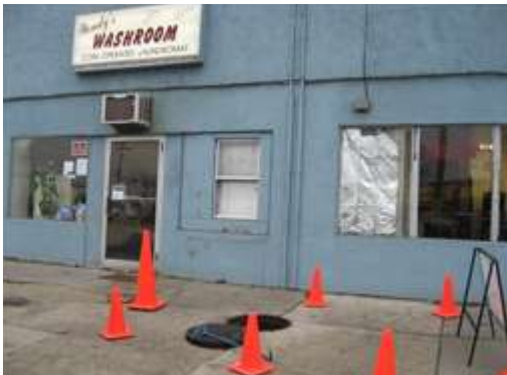
Location View

E. Patapsco Ave.

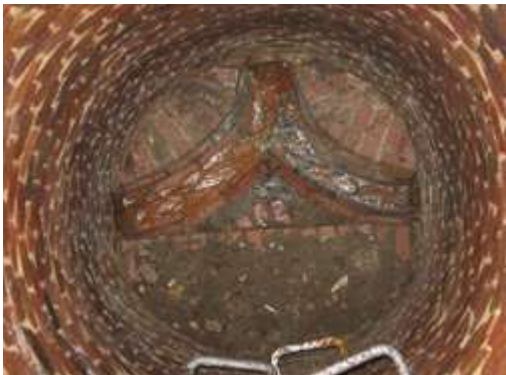
Top View

Steps

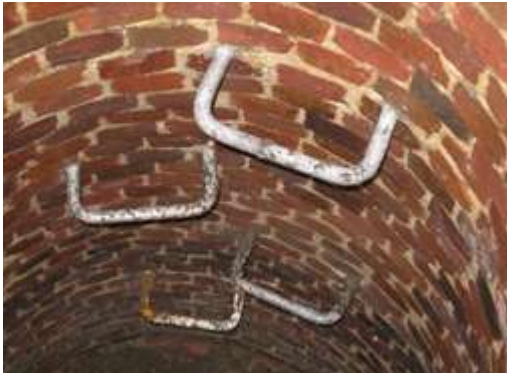
Steps

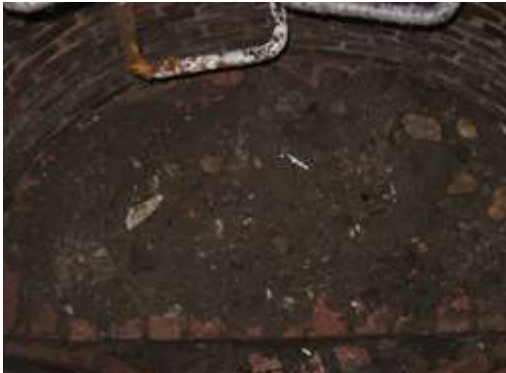
Defect 1

Debris

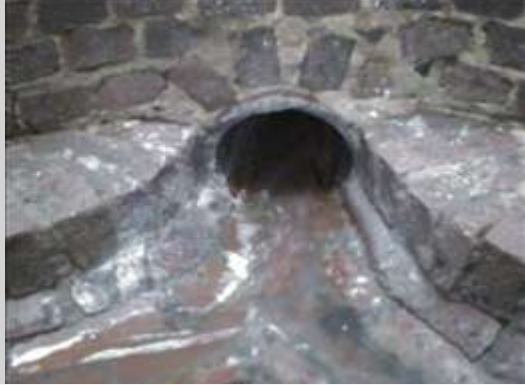
12 O'Clock Outflow

8 in. Circular Gravity Sewer  
Pipe Out @ 12 O'Clock

Pipe Height: **9.6** (in.) Rod and Bar (Angled)  
Pipe Material: **Clay** ☐ Pipe Lined  
Invert Depth: **9.56** (ft.) Flow Characteristics: **Fast**  
Deposits: ☒ None ☐ Mud ☐ Sludge ☐ Debris ☐ Grease  
Silt Depth: (in.) Deposits Extent:  
Infiltration: **None** Pipe Seal Cond: **Sound**

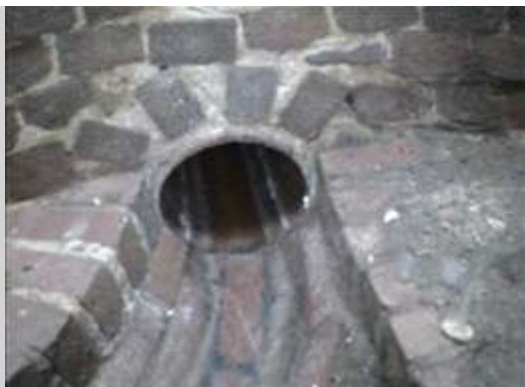
3 O'Clock Inflow

8 in. Circular Gravity Sewer  
Pipe In @ 3 O'Clock

Pipe Height: **9.6** (in.) Rod and Bar (Angled)  
Pipe Material: **Clay** ☐ Pipe Lined  
Invert Depth: **9.45** (ft.) Flow Characteristics: **Fast**  
Deposits: ☒ None ☐ Mud ☐ Sludge ☐ Debris ☐ Grease  
Silt Depth: (in.) Deposits Extent:  
Infiltration: **None** Pipe Seal Cond: **Sound**

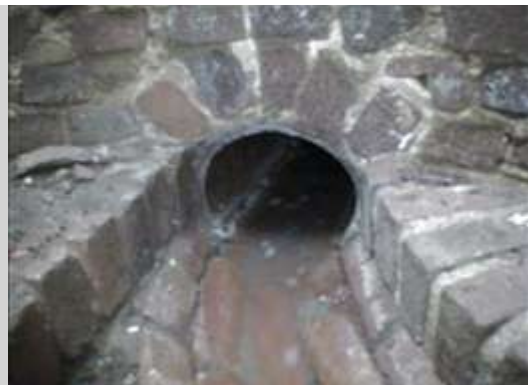
9 O'Clock Inflow

8 in. Circular Gravity Sewer  
Pipe In @ 9 O'Clock

Pipe Height: **9.6** (in.) Rod and Bar (Angled)

Pipe Material: **Clay** ☐ Pipe Lined

Invert Depth: **9.41** (ft.) Flow Characteristics: **Fast**

Deposits: ☒ None ☐ Mud ☐ Sludge ☐ Debris ☐ Grease

Infiltration: **None** Pipe Seal Cond: **Sound**
